Lockheed Aircraft Corporation

REPORT NO. SP-1622

MODEL U-2R

TITLE TEST OF EJECTION SEAT
CANOPY BREAKER EXTENSION

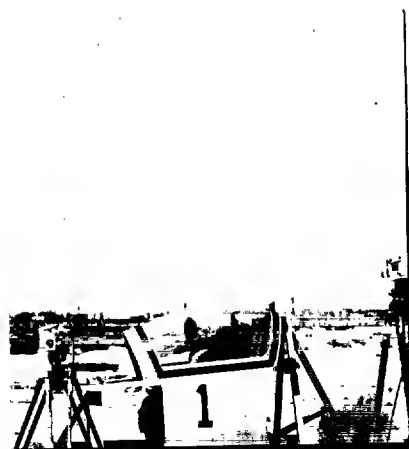
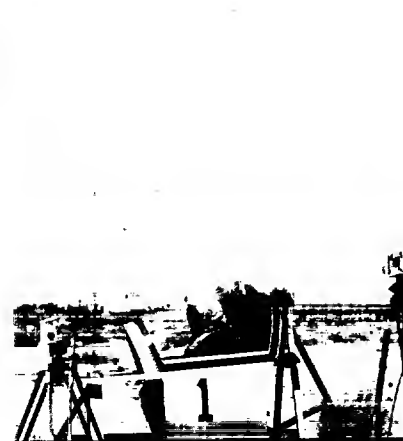
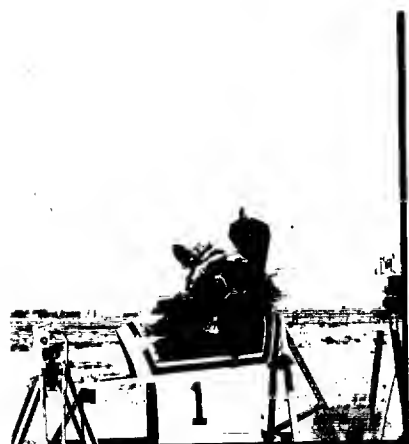
1. Prior to firing.
2. The initiator has fired the catapult and the seat has moved up to contact the glass. Note the black smoke from the initiator coming up the aft bulkhead. This occurs after the catapult moves the rocket up far enough to separate the mated connections of the initiator line.
3. The catapult has forced the Canopy Breaker through the canopy.
4. The pilot and seat are emerging through the canopy and the rocket has ignited.
5. The seat has cleared the tracks and the Seat Drogue Chute Gun has fired to deploy the stabilizing chute.
6. The test is successful.

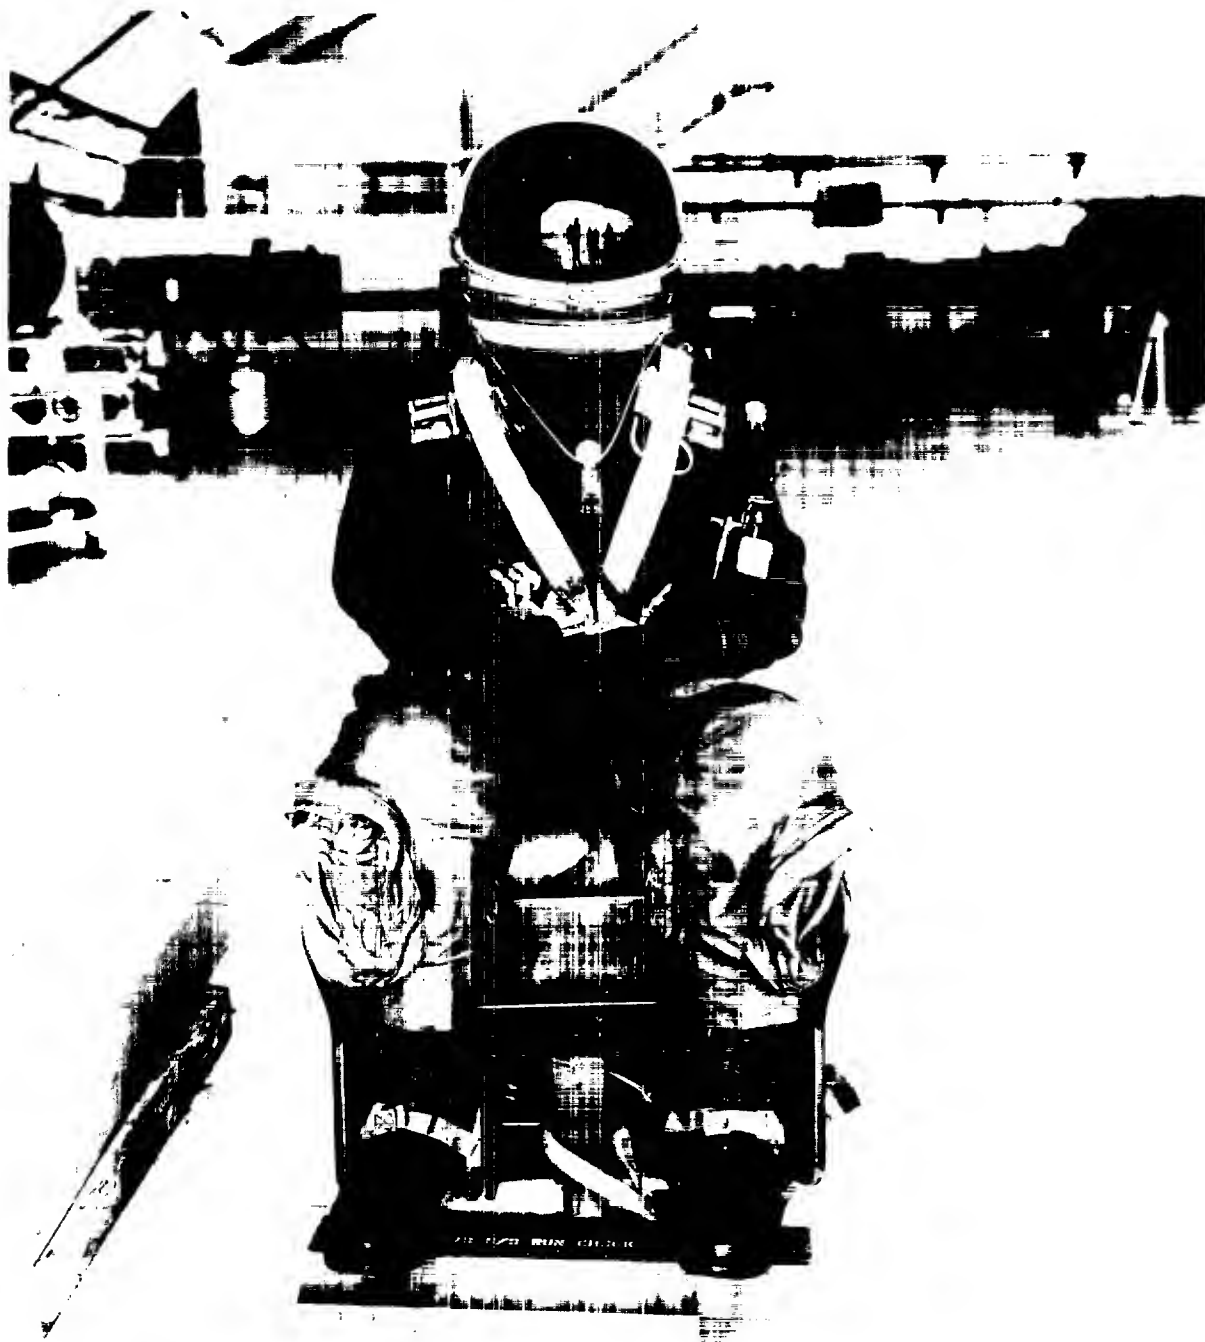
PHOTO NO. 1

- 4.1 The seat was plumbed and the pyrotechnics added. The recovery chute was packed in the box below the seat with its gun packed. The dummy was strapped in. Photo No. 1.
- 4.2 The seat was loaded into the sled after the installation of the catapult. Photo No. 2.
- 4.3 The test sled was located on the test site so that the predicted seat impact point would be on sand to reduce damage to the seat. Photo No. 3.
- 4.4 The canopy was installed and locked down. Photo No. 3.
- 4.5 The cameras were located, power to run them provided, and loaded with film. Photo No. 4.
- 4.6 The pressure suit was inflated to approximately 1 psig.

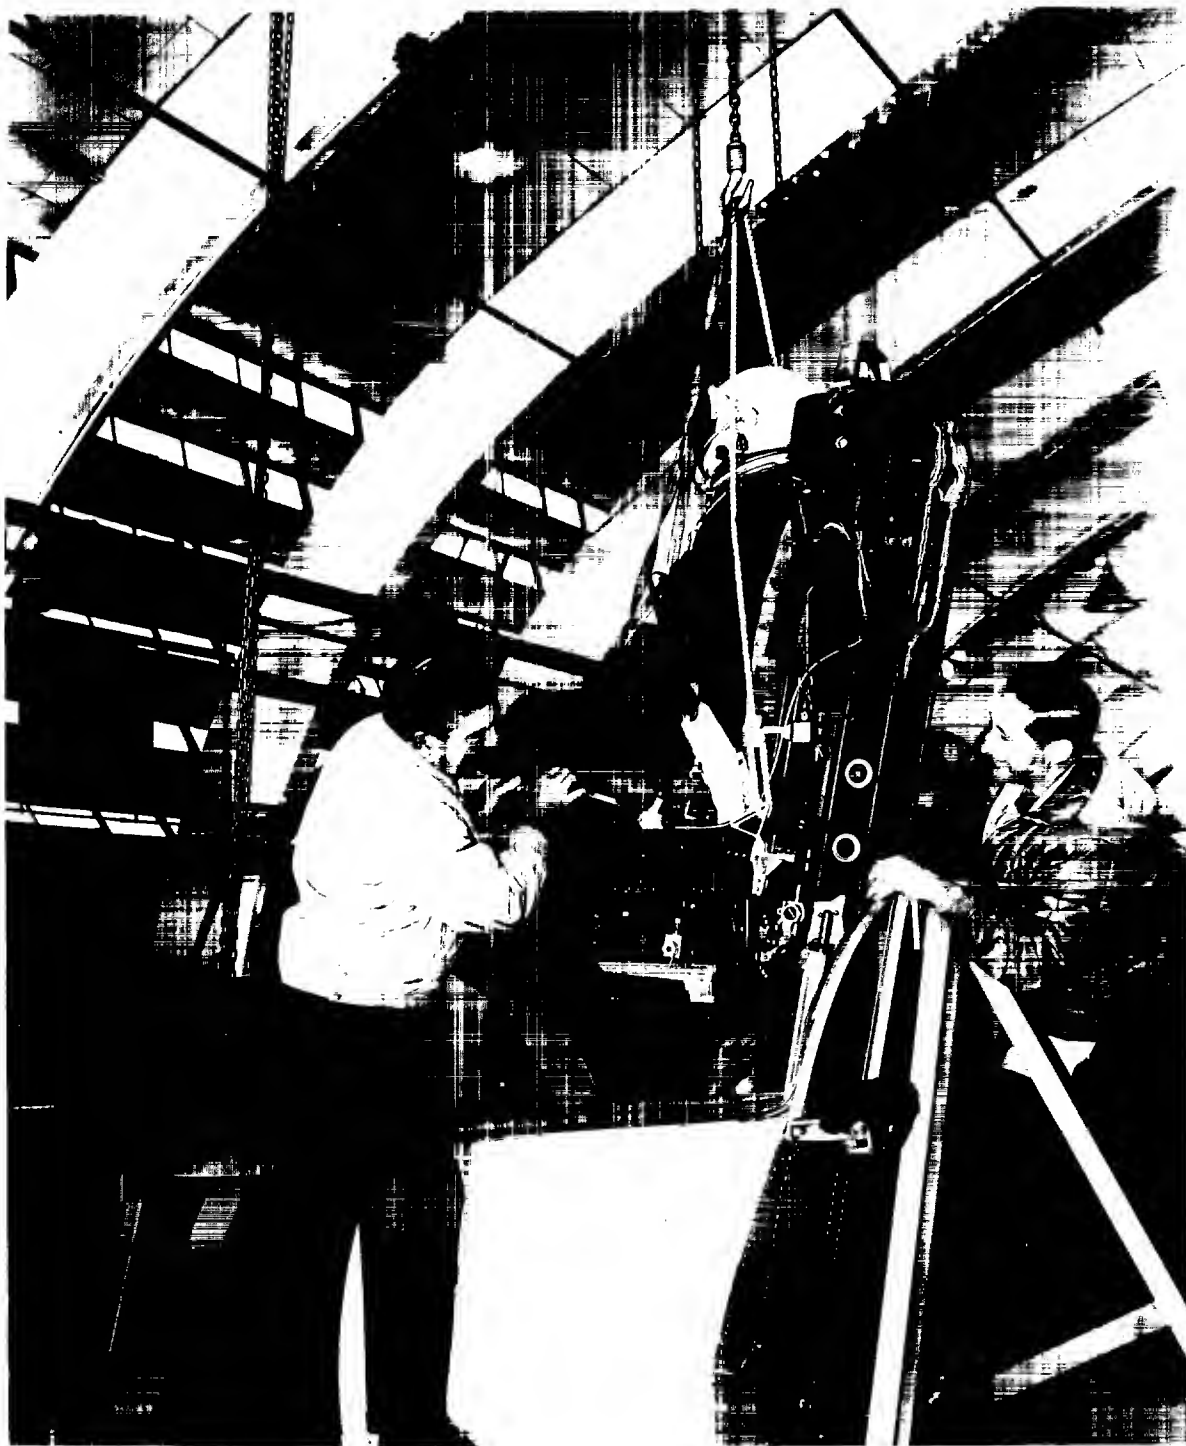
PHOTO NO. 2

The thicker cushion raises the pilot to the point where the shoulder straps of the parachute will bear on his shoulders. (See Photo No. 2.) The dummy had to be pushed down into the cushion to allow the chute to slip into its allotted space. Thus the dummy was carrying the weight of the chute on his shoulders.

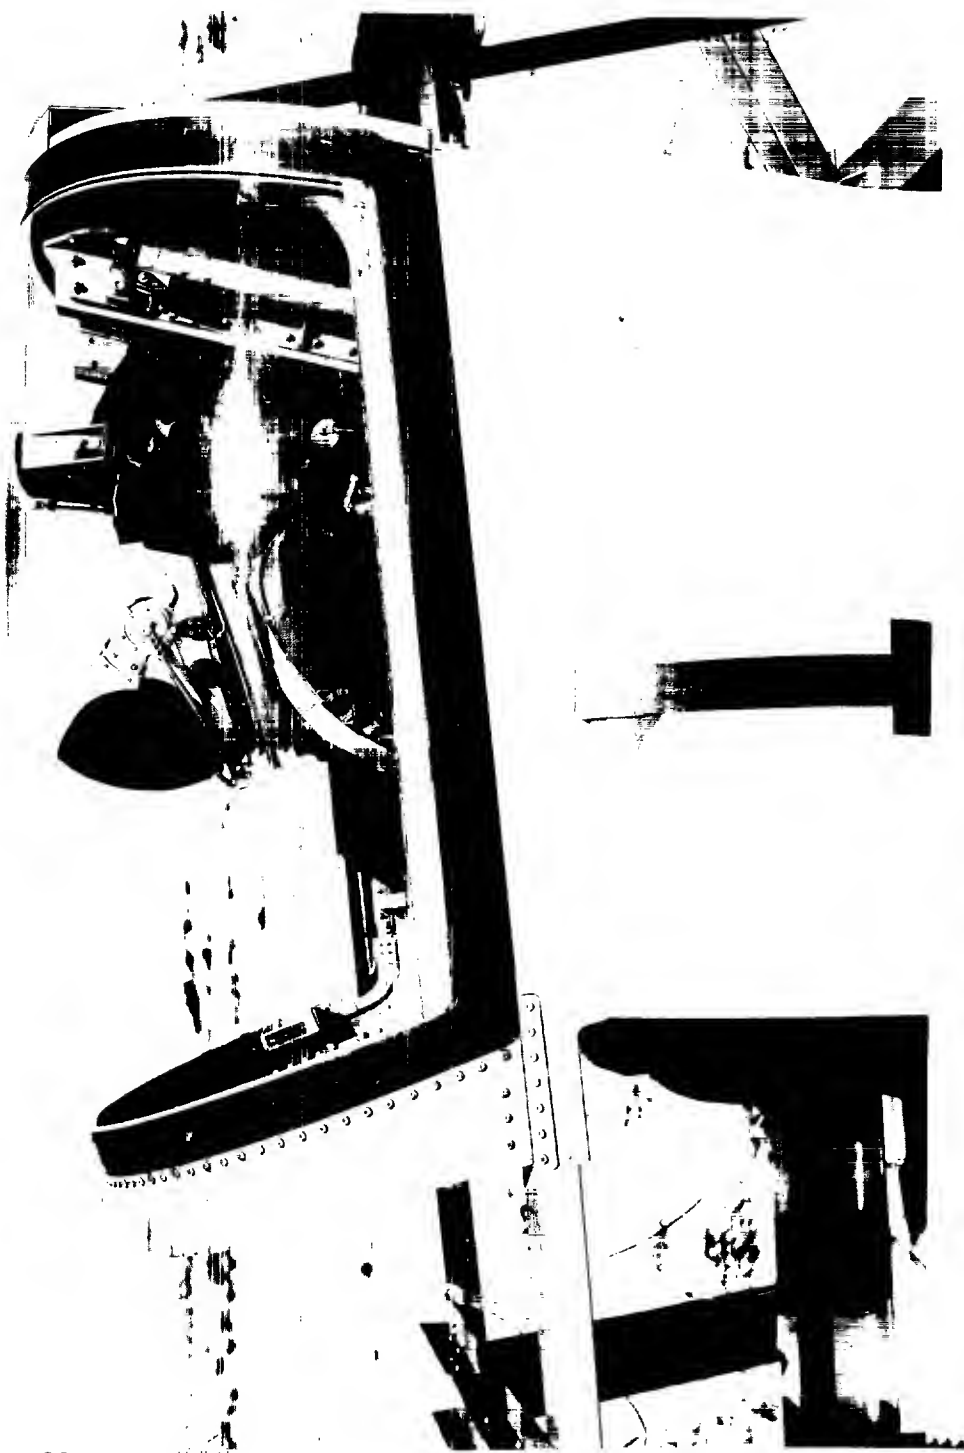
PHOTO NO. 3

- 5.1.1 Photo No. 3 illustrates the proximity of the canopy breaker and the dummy's helmet to the canopy. This is the uppermost position permitted by the limit switch in the seat raising circuit. The small ball tipped rod on the breaker is the feeler that opens the limit switch when the rubber pad is one quarter inch from the glass.
